## Technical Memorandum

Re: Aris T Allen Boulevard property, Wetlands and Waters Delineation Verification  
EP#: 20130099

# Aris T Allen – Wetland Verification Study Map

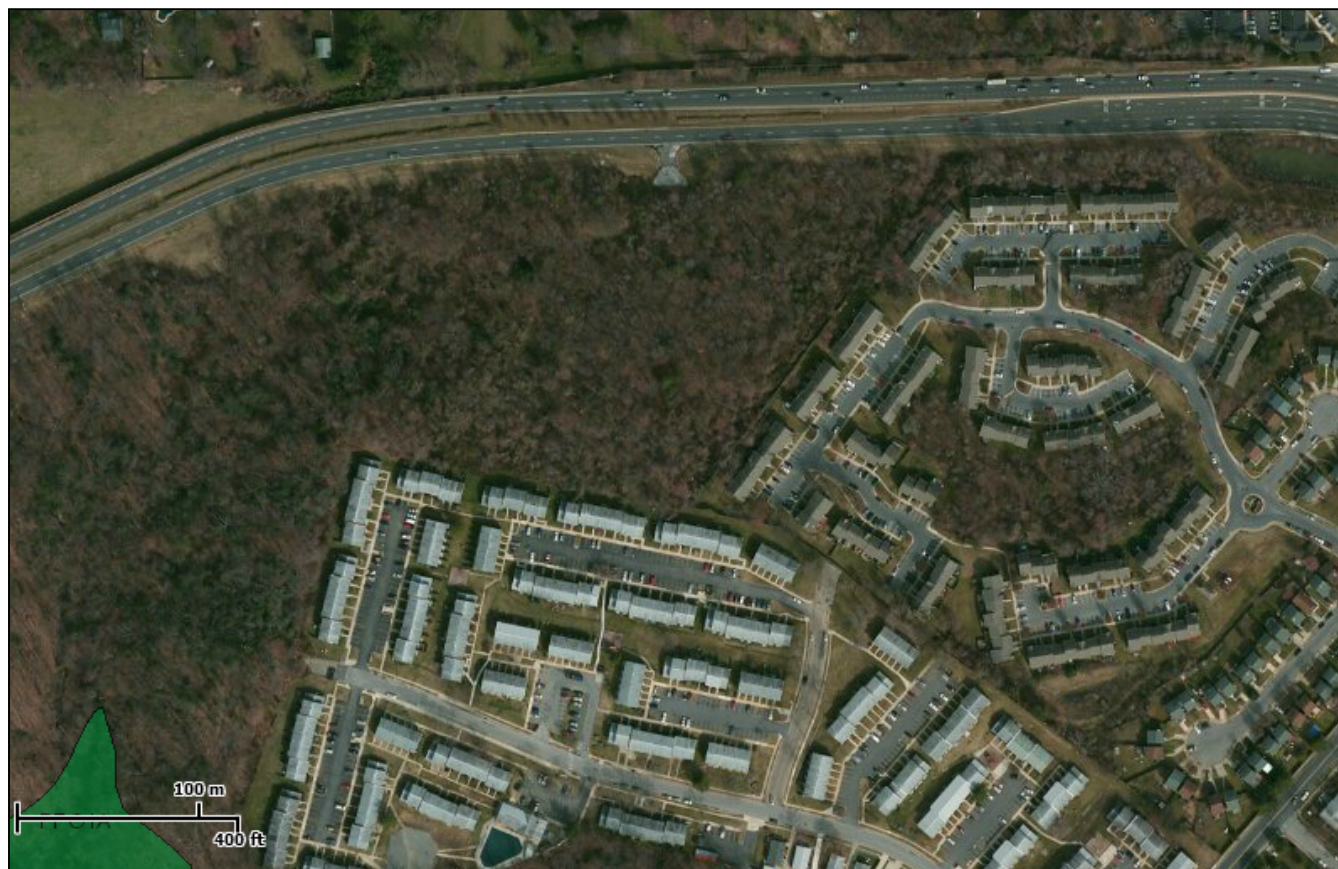
Figure 4: NWI MAP

- The National Wetlands Inventory (NWI) map (Figure 4) shows no mapped wetlands within the project study area.
- The project occurs within the headwaters of Church Creek, draining to the South River, Use Class I watershed. Hydrologic Unit Code (HUC) is 020600040302.

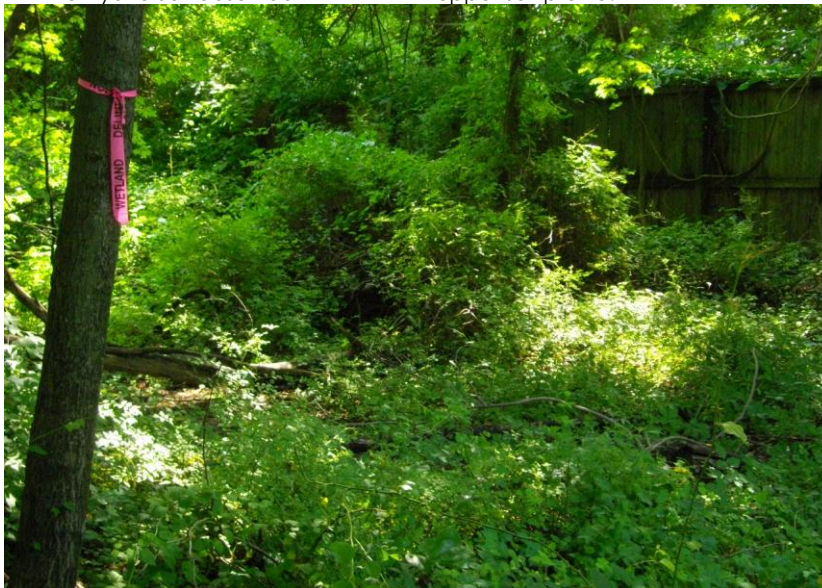
Photograph of Upland Data Point

UPLAND DATA POINT A

No Hydric Soil observed within within upper soil profile.

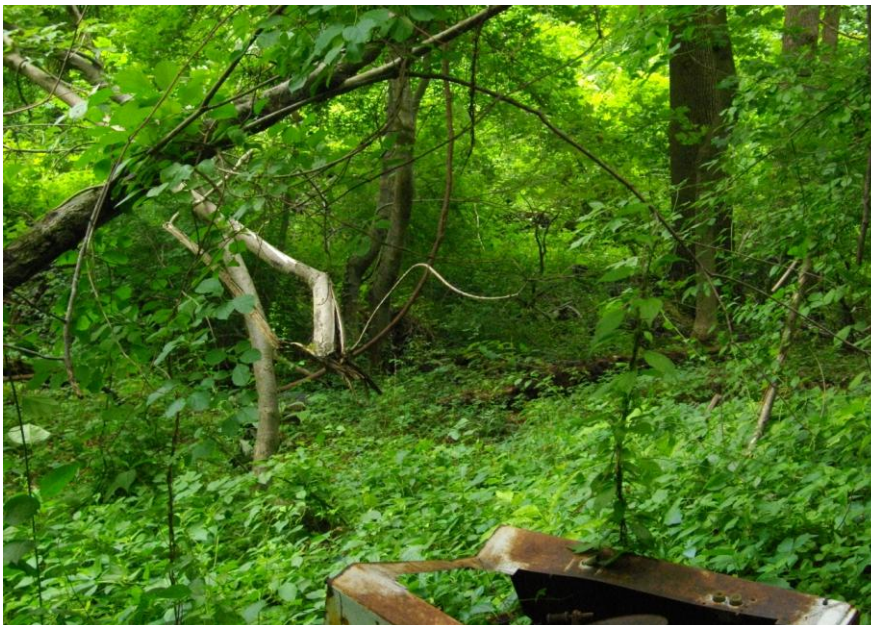
Photo of Upland Data Point

UPLAND DATA POINT B

Hydrophytic vegetation parameters NOT satisfied
